Flood Control Project Maintenance
Levee Inspections

Fall 2013 Levee Maintenance Deficiency Summary Report

Reclamation District No. 1001 Nicolaus

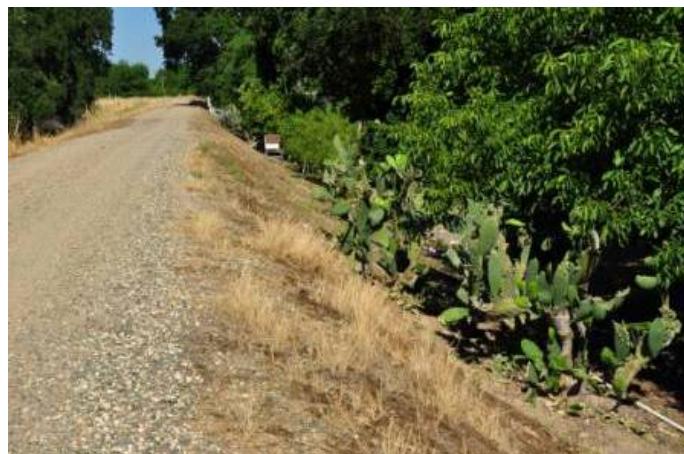
Levee Mile Report Line	11
Start Levee Mile	3.16
End Levee Mile	3.22
Location	Land Side
Category	Earthen Levee
Item	Vegetation
RD 1001 Unit 1 - Landscaping	
mhoffman_f_20130917_140.JPG

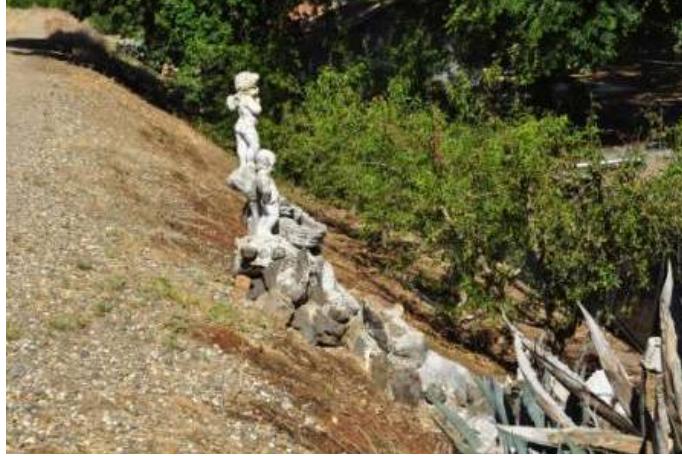
Levee Mile Report Line	11
Start Levee Mile	3.16
End Levee Mile	3.22
Location	Land Side
Category	Earthen Levee
Item	Vegetation
RD 1001 Unit 1 - L/S - Landscaping	
mhoffman_f_20130917_141.JPG

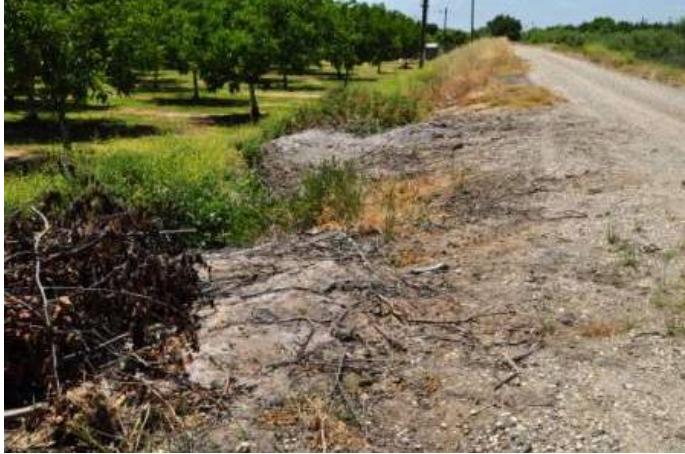
Levee Mile Report Line	5
Start Levee Mile	0.58
End Levee Mile	0.58
Location	Land Side
Category	Earthen Levee
Item	Encroachments
RD 1001 Unit 2 - L/S - Prunning Piles

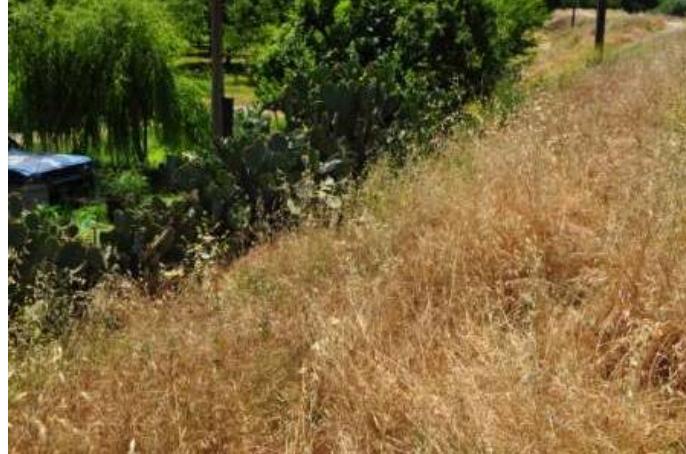
Levee Mile Report Line	6
Start Levee Mile	0.67
End Levee Mile	0.67
Location	Land Side
Category	Earthen Levee
Item	Vegetation
RD 1001 Unit 2 - L/S -Landscaping - Cactus and fruit trees	
mhoffman_f_20130917_155.JPG

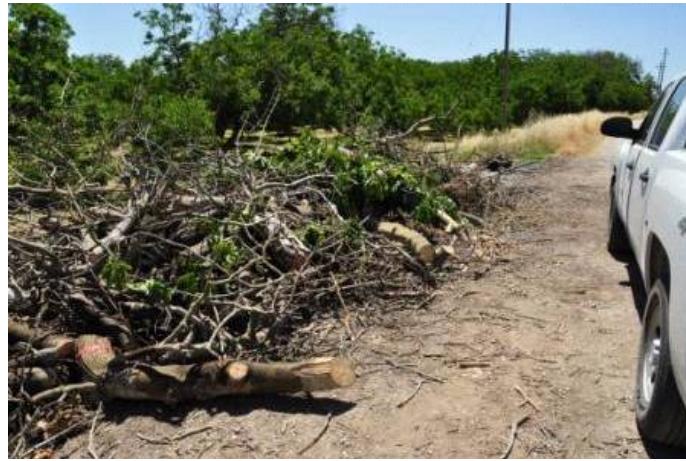
Levee Mile Report Line	7
Start Levee Mile	0.81
End Levee Mile	0.81
Location	Land Side
Category	Earthen Levee
Item	Encroachments
RD 1001 Unit 2 - L/S - Prunning Piles	
mhoffman_f_20130917_149.JPG

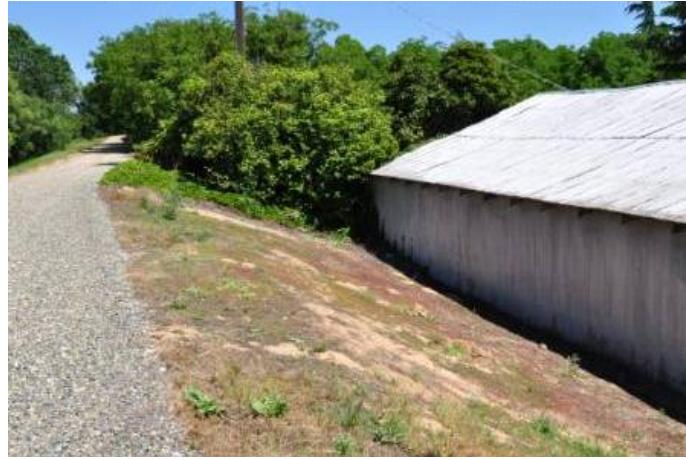
Levee Mile Report Line	11
Start Levee Mile	1.77
End Levee Mile	1.77
Location	Land Side
Category	Earthen Levee
Item	Vegetation
RD 1001 Unit 2 - L/S -Landscaping - Trees	
mhoffman_f_20130917_151.JPG

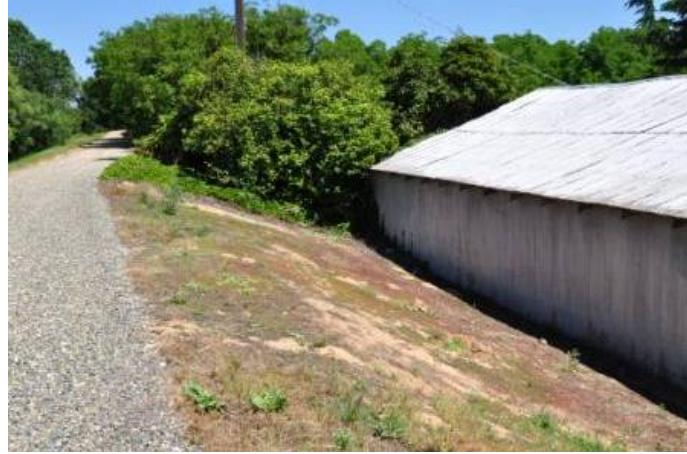
Levee Mile Report Line	12
Start Levee Mile	1.78
End Levee Mile	1.78
Location	Land Side
Category	Earthen Levee
Item	Encroachments
RD 1001 Unit 2 - L/S -Building @ toe.	
mhoffman_f_20130917_152.JPG

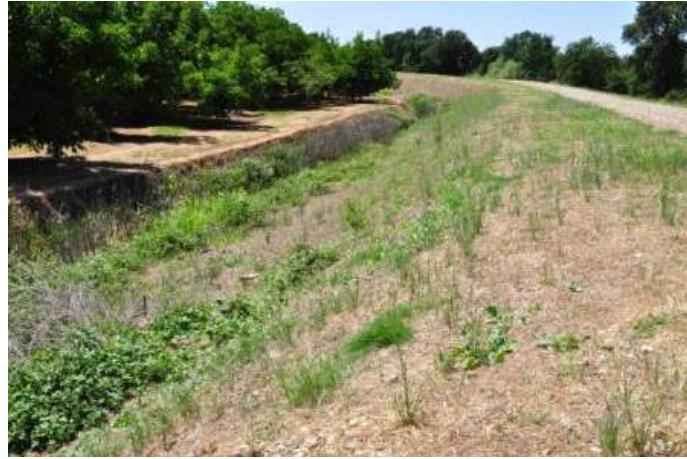
Levee Mile Report Line	14
Start Levee Mile	2.32
End Levee Mile	2.55
Location	Land Side
Category	Earthen Levee
Item	Encroachments
RD 1001 Unit 2 - L/S - Drainage Ditch @ toe.	
mhoffman_f_20130917_157.JPG

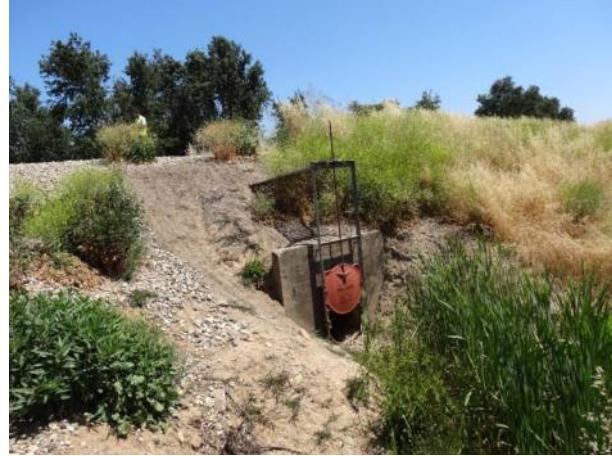
Levee Mile Report Line	15
Start Levee Mile	2.32
End Levee Mile	2.32
Location	Land Side
Category	Supplemental
Item	DWR UCIP Field Study
LS- slide gate in inlet pipe structure	
UCIP_7515.jpg

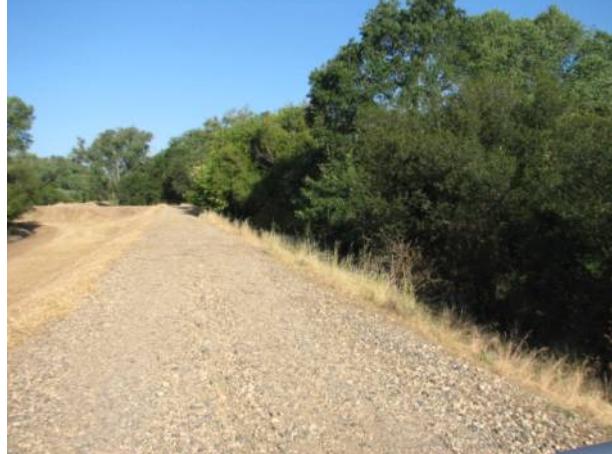
mhoffman_f_20130917_182.JPG

Levee Mile Report Line	2
Start Levee Mile	0.11
End Levee Mile	0.11
Location	Crown
Category	Earthen Levee
Item	Slope Stability

This photo was taken from the crown of the levee facing west looking down the slope at rutting caused by vehicles driving up the landward levee slope.

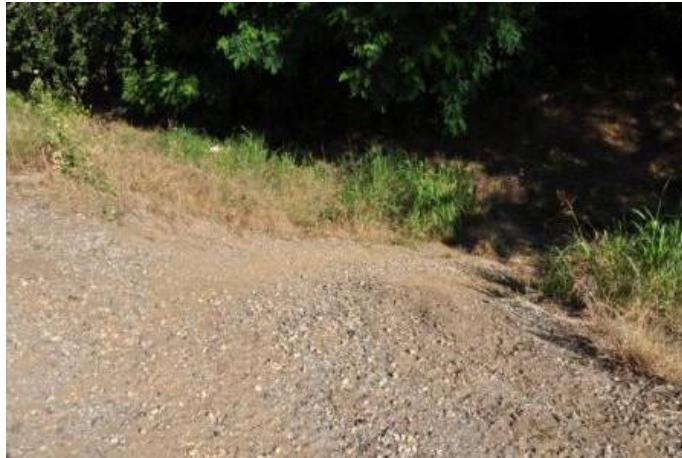
Levee Mile Report Line	7
Start Levee Mile	1.06
End Levee Mile	1.06
Location	Water Side
Category	Earthen Levee
Item	Slope Stability
RD 1001 Unit 3 - Slope damage	
mhoffman_f_20130917_159.JPG

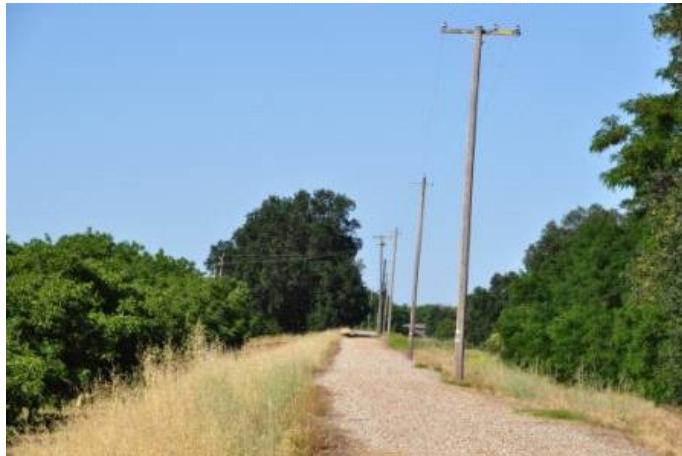
Levee Mile Report Line	9
Start Levee Mile	1.21
End Levee Mile	1.77
Location	Water Side
Category	Earthen Levee
Item	Encroachments
RD 1001 Unit 3 - Power Poles along W/S shoulder.	
mhoffman_f_20130917_158.JPG

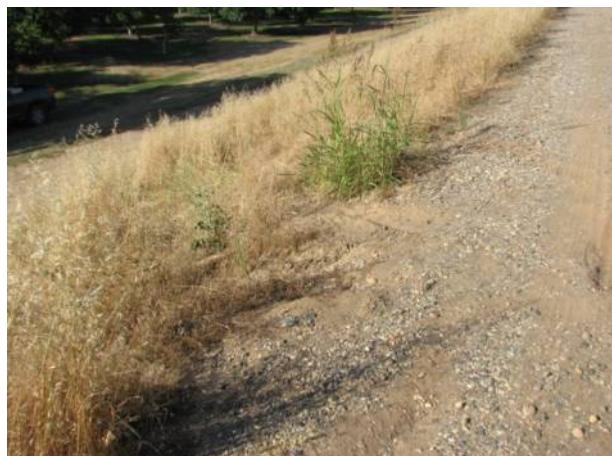
Levee Mile Report Line	10
Start Levee Mile	1.87
End Levee Mile	1.87
Location	Land Side
Category	Earthen Levee
Item	Slope Stability
Damage caused by vehicles. Spring 2013	
mhoffman_f_20130917_186.JPG

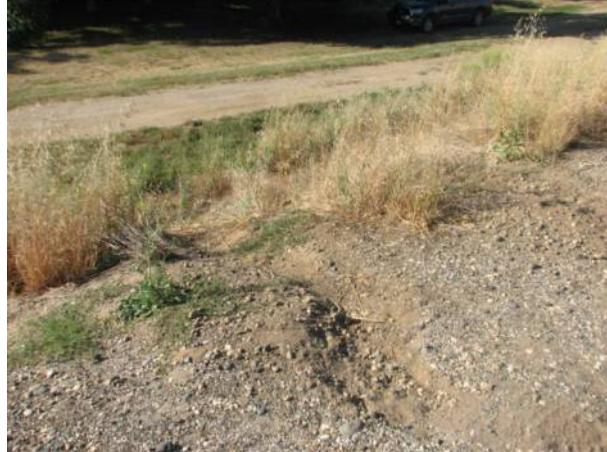
Levee Mile Report Line	10
Start Levee Mile	1.87
End Levee Mile	1.87
Location	Land Side
Category	Earthen Levee
Item	Slope Stability
Damage caused by vehicles going around the gate. Spring 2013	
mhoffman_f_20130917_187.JPG

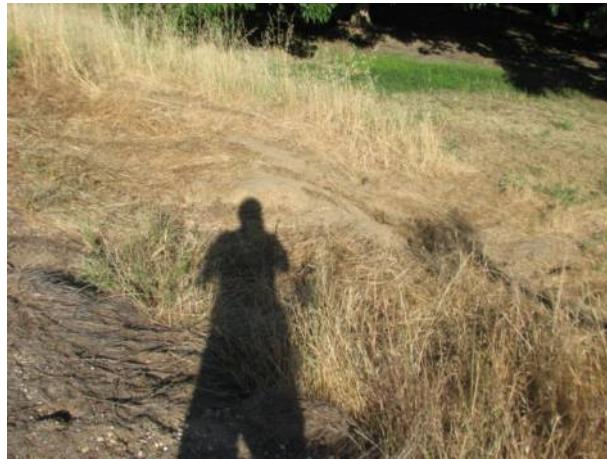
Levee Mile Report Line	11
Start Levee Mile	1.87
End Levee Mile	1.87
Location	Water Side
Category	Earthen Levee
Item	Slope Stability
Damage caused by vehicles. Spring 2013	
mhoffman_f_20130917_184.JPG

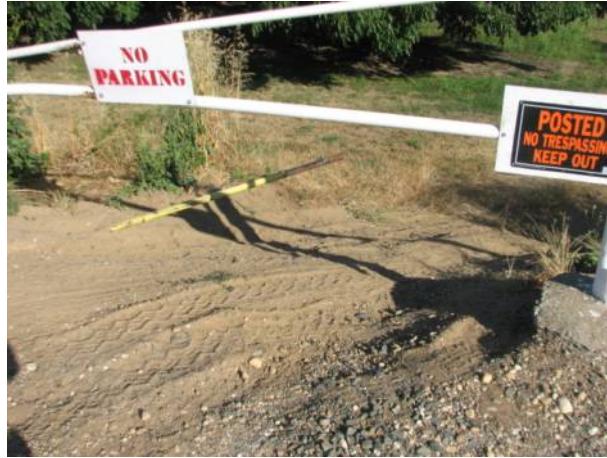
Levee Mile Report Line	11
Start Levee Mile	1.87
End Levee Mile	1.87
Location	Water Side
Category	Earthen Levee
Item	Slope Stability
Damage caused by vehicles Spring 2013	
mhoffman_f_20130917_185.JPG

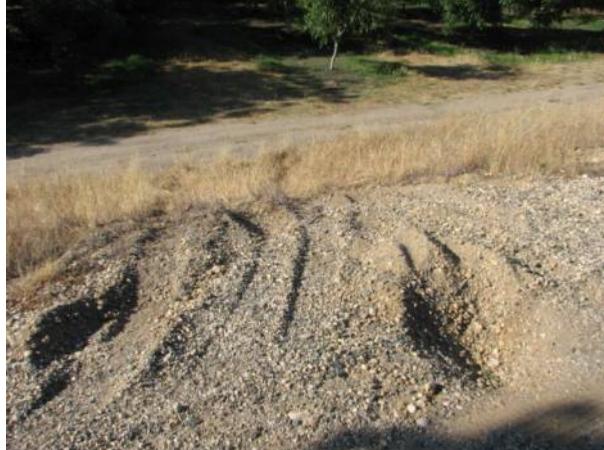
Levee Mile Report Line	13
Start Levee Mile	2.29
End Levee Mile	2.29
Location	Land Side
Category	Earthen Levee
Item	Slope Stability
Damage caused by vehicles. Spring 2013	
mhoffman_f_20130917_188.JPG

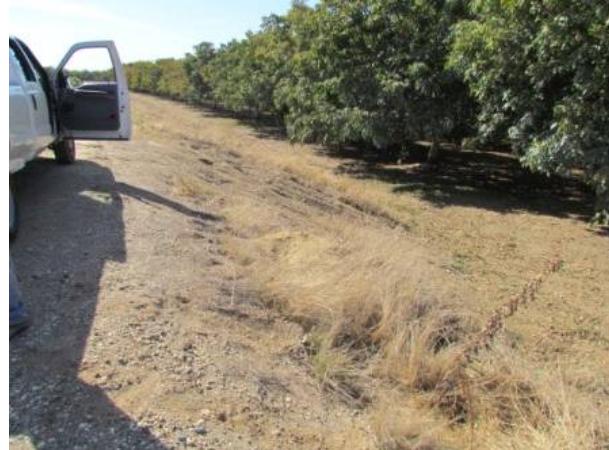
mhoffman_f_20131018_662.JPG

This photo was taken from the crown of the levee facing west looking down the slope at rutting caused by vehicles driving up the waterward levee slope.

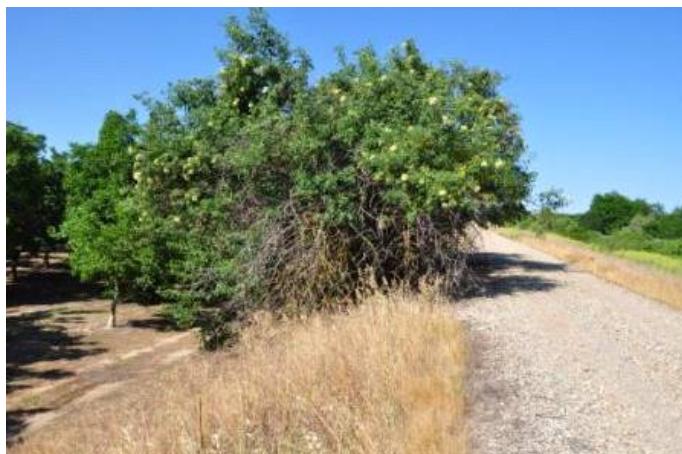
Levee Mile Report Line	33
Start Levee Mile	4.85
End Levee Mile	4.85
Location	Land Side
Category	Earthen Levee
Item	Vegetation
RD 1001 Unit 3 - L/S slope -Elderberries	
mhoffman_f_20130917_201.JPG

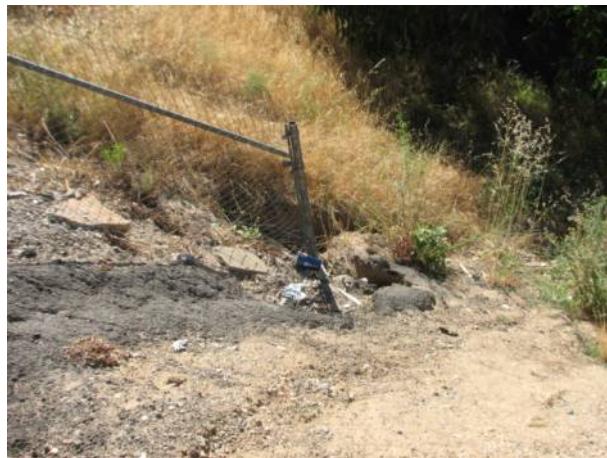
Levee Mile Report Line	38
Start Levee Mile	6.50
End Levee Mile	6.50
Location	Land Side
Category	Earthen Levee
Item	Erosion / Bank Caving
Erosion caused by run off from the roadway. Spring 2013	
mhoffman_f_20130917_196.JPG

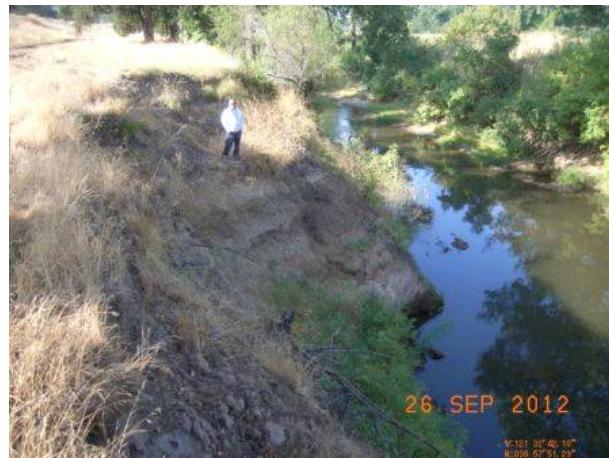
Levee Mile Report Line	44
Start Levee Mile	10.60
End Levee Mile	10.60
Location	Water Side
Category	Earthen Levee
Item	Encroachments
USACE 2012 Photo #1	
mhoffman_f_20130917_168.jpg

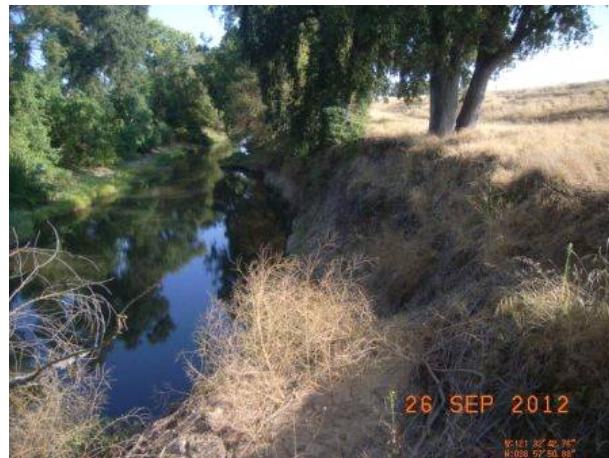
Levee Mile Report Line	44
Start Levee Mile	10.60
End Levee Mile	10.60
Location	Water Side
Category	Earthen Levee
Item	Encroachments
USACE 2012 Photo #2	
mhoffman_f_20130917_169.jpg

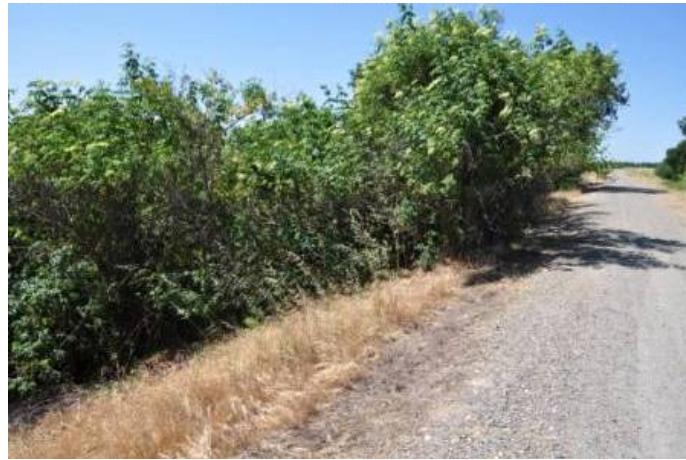
Levee Mile Report Line	48
Start Levee Mile	11.29
End Levee Mile	11.32
Location	Land Side
Category	Earthen Levee
Item	Vegetation
RD 1001 Unit 3 - L/S slope -Elderberries	
mhoffman_f_20130917_179.JPG

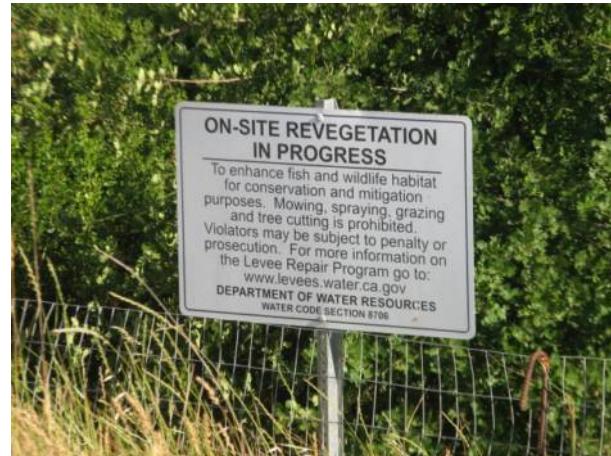
Levee Mile Report Line	50
Start Levee Mile	11.65
End Levee Mile	11.86
Location	Water Side
Category	Earthen Levee
Item	Vegetation
Revegetation site in progress. Spring 2013	
mhoffman_f_20130917_181.JPG

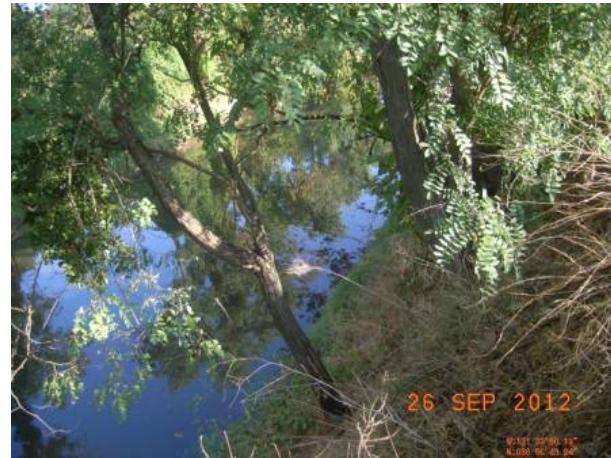
Levee Mile Report Line	52
Start Levee Mile	12.13
End Levee Mile	12.22
Location	Water Side
Category	Supplemental
Item	USACE Erosion Survey
USACE 2012 Photo #1	
USACE2013_BER_0-8_L_1.jpg

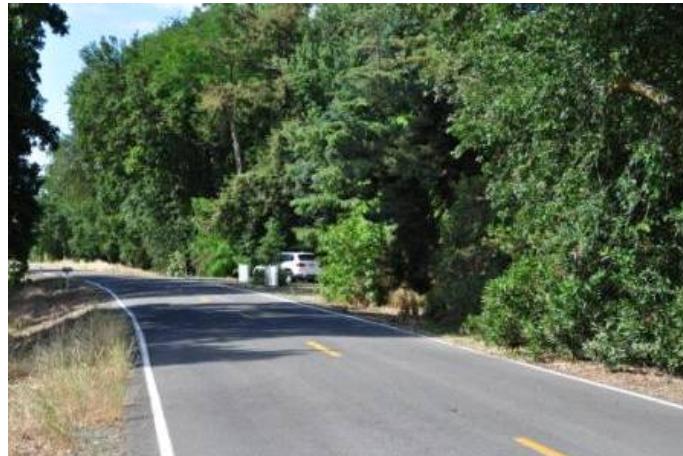
Levee Mile Report Line	27
Start Levee Mile	9.74
End Levee Mile	9.74
Location	Water Side
Category	Earthen Levee
Item	Vegetation
RD 1001 Unit 4 - W/S slope -Landscaping/Trees	mhoffman_f_20130917_244.JPG

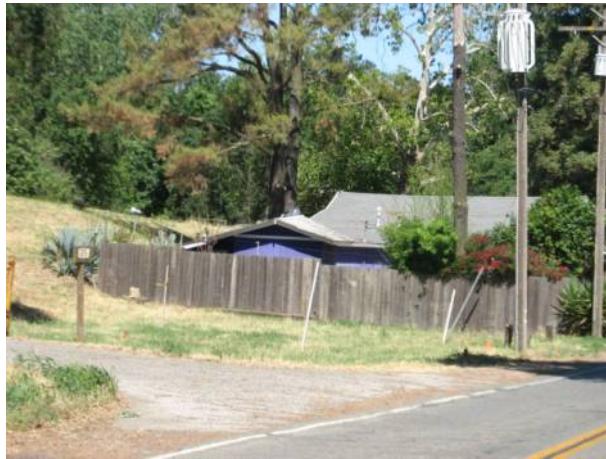
Levee Mile Report Line	43
Start Levee Mile	12.57
End Levee Mile	12.57
Location	Land Side
Category	Earthen Levee
Item	Encroachments
A building is at the toe of the levee. Spring 2013	
mhoffman_f_20130917_248.JPG

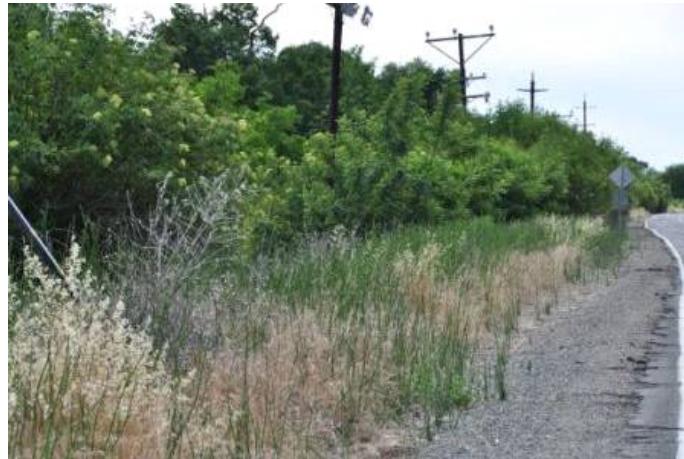
Levee Mile Report Line	45
Start Levee Mile	12.76
End Levee Mile	13.21
Location	Water Side
Category	Earthen Levee
Item	Vegetation
RD 1001 Unit 4 - W/S slope - Elderberries	
mhoffman_f_20130917_235.JPG

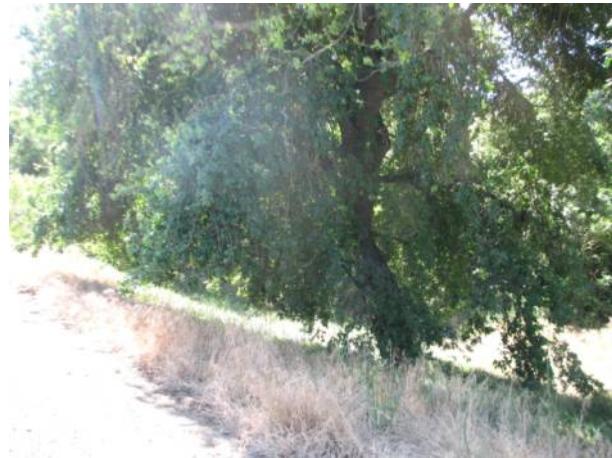
Levee Mile Report Line	47
Start Levee Mile	12.91
End Levee Mile	12.91
Location	Water Side
Category	Earthen Levee
Item	Trim / Thin Trees
Trees need to be trimmed up at least 5 feet. Spring 2013	
mhoffman_f_20130917_259.JPG

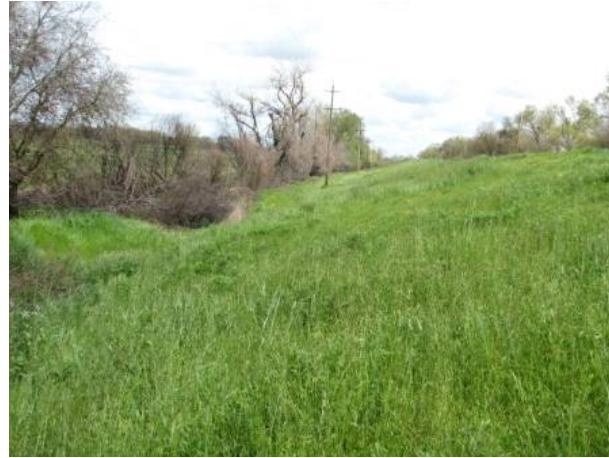
Levee Mile Report Line	2
Start Levee Mile	0.19
End Levee Mile	0.86
Location	Land Side
Category	Earthen Levee
Item	Encroachments
Poles at the land side toe levee mile 0.19 - 0.86.	mhoffman_f_20130917_264.jpg

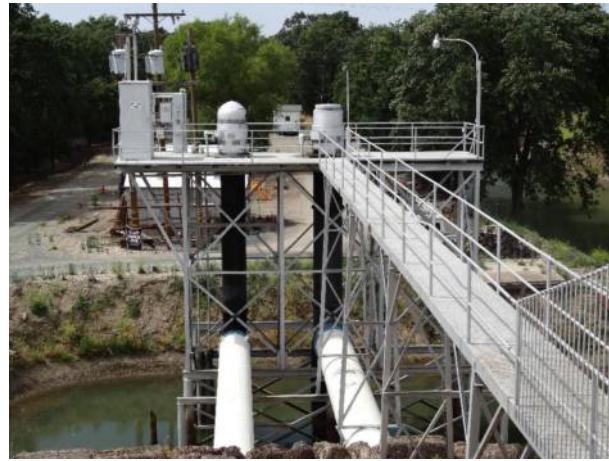
Levee Mile Report Line	3
Start Levee Mile	0.77
End Levee Mile	0.77
Location	Land Side
Category	Supplemental
Item	DWR UCIP Field Study
LS- pumps, pipes, and walkway	
UCIP_7604.jpg

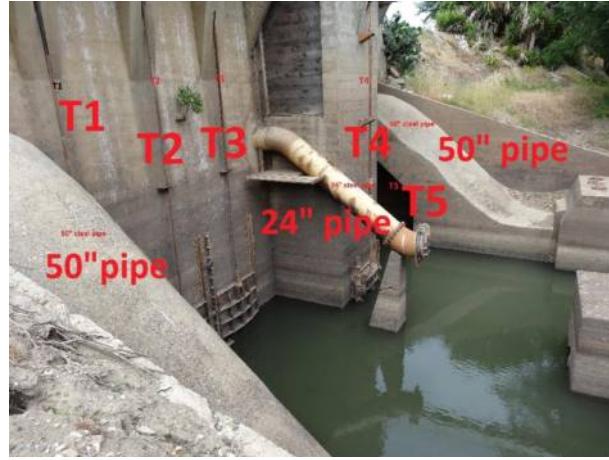
Levee Mile Report Line	8
Start Levee Mile	0.80
End Levee Mile	0.80
Location	Land Side
Category	Supplemental
Item	DWR UCIP Field Study
WS- three steel pipes inside tunnel. Fifty inch pipes on left and right. Twenty four inch pipe in middle of the structure as shown.	
UCIP_7675.jpg

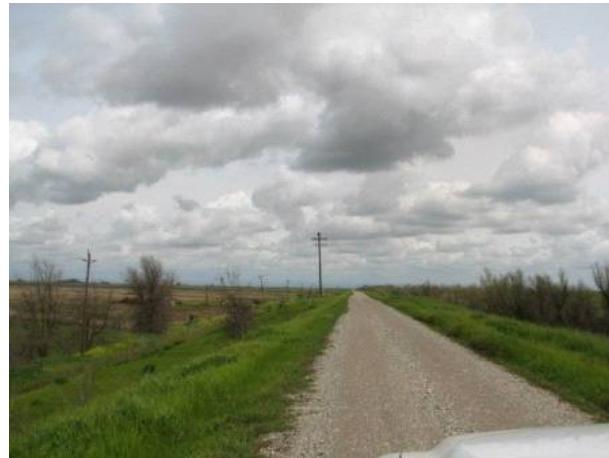
Levee Mile Report Line	10
Start Levee Mile	1.15
End Levee Mile	1.15
Location	Land Side
Category	Earthen Levee
Item	Encroachments
Pole on land side shoulder levee mile 1.15.	mhoffman_f_20130917_266.jpg

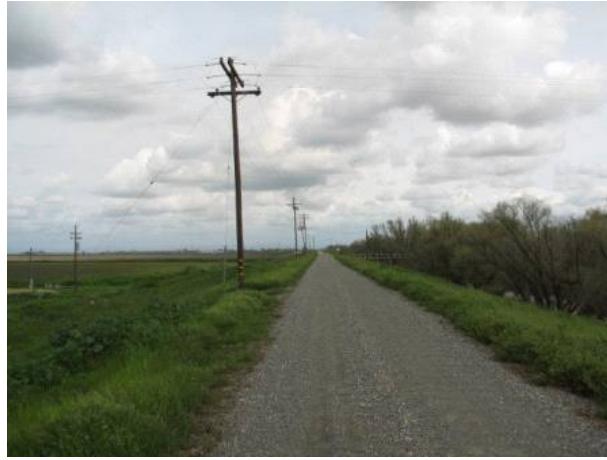
Levee Mile Report Line	13
Start Levee Mile	3.59
End Levee Mile	3.85
Location	Land Side
Category	Earthen Levee
Item	Encroachments
Poles on the land side shoulder levee mile 3.59 - 3.85.	
mhoffman_f_20130917_268.jpg

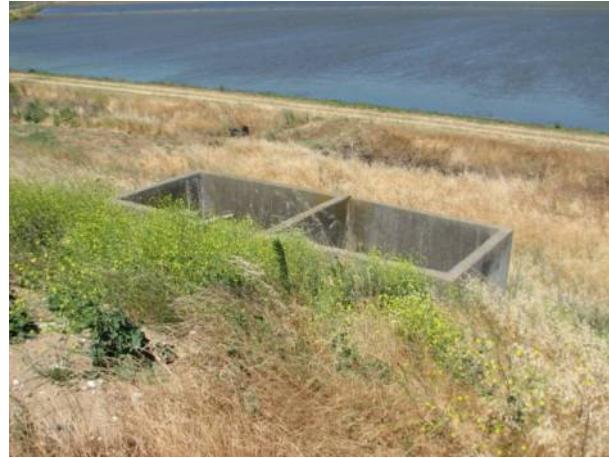
Levee Mile Report Line	15
Start Levee Mile	3.73
End Levee Mile	3.73
Location	Water Side
Category	Earthen Levee
Item	Encroachments
Concrete distribution box on the landside levee slope. Spring 2013	
mhoffman_f_20130917_271.JPG

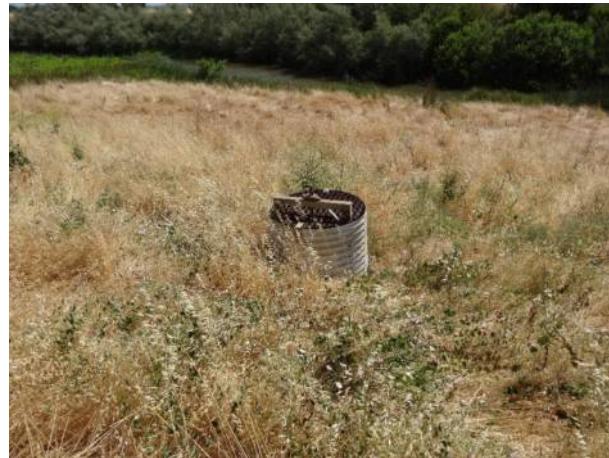
Levee Mile Report Line	18
Start Levee Mile	3.93
End Levee Mile	3.93
Location	Land Side
Category	Supplemental
Item	DWR UCIP Field Study
WS- slide gate, air vent in CMP riser on levee slope	UCIP_7308.jpg

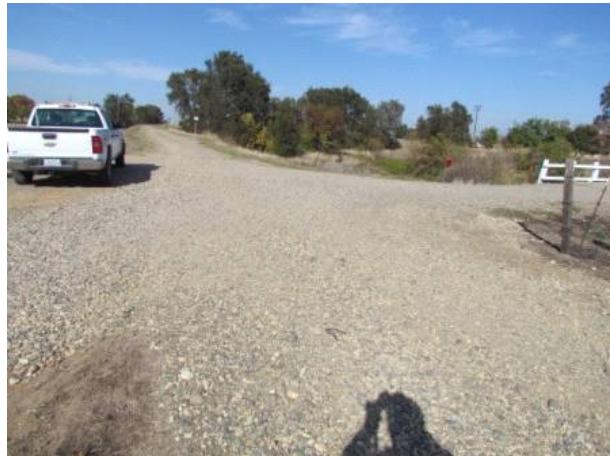
Levee Mile Report Line	20
Start Levee Mile	4.35
End Levee Mile	4.35
Location	Crown
Category	Earthen Levee
Item	Slope Stability
This photo was taken from the levee crown facing north looking at subsidence due to vehicle traffic across crown. Fall 2013.	
mhoffman_f_20131028_683.JPG
